## Section 17 - CURTIS SCHOOL

### Building Summary

**Address:** 848 Main St.

## **Town of Hanover - MUNICIPAL FACILITIES ASSESSMENT - 2010**

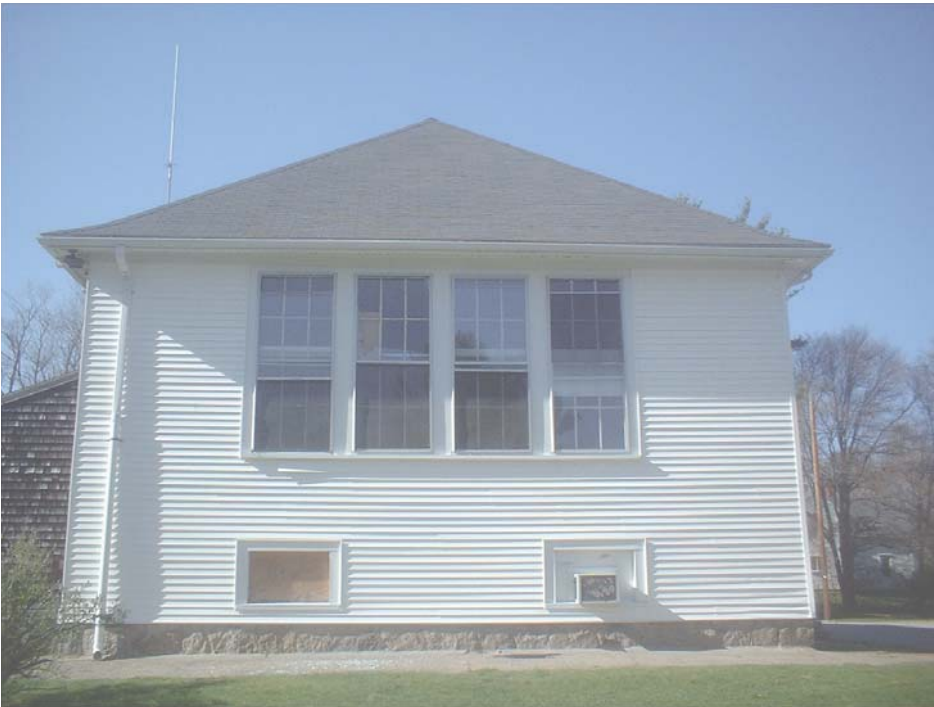
- Rear basement entry choked with plant growth.
- Holes in vertical corner wood trim appear to be caused by pests.
- Broken window on south side, glass debris on ground.

Exterior view of south facade, broken glass on ground.

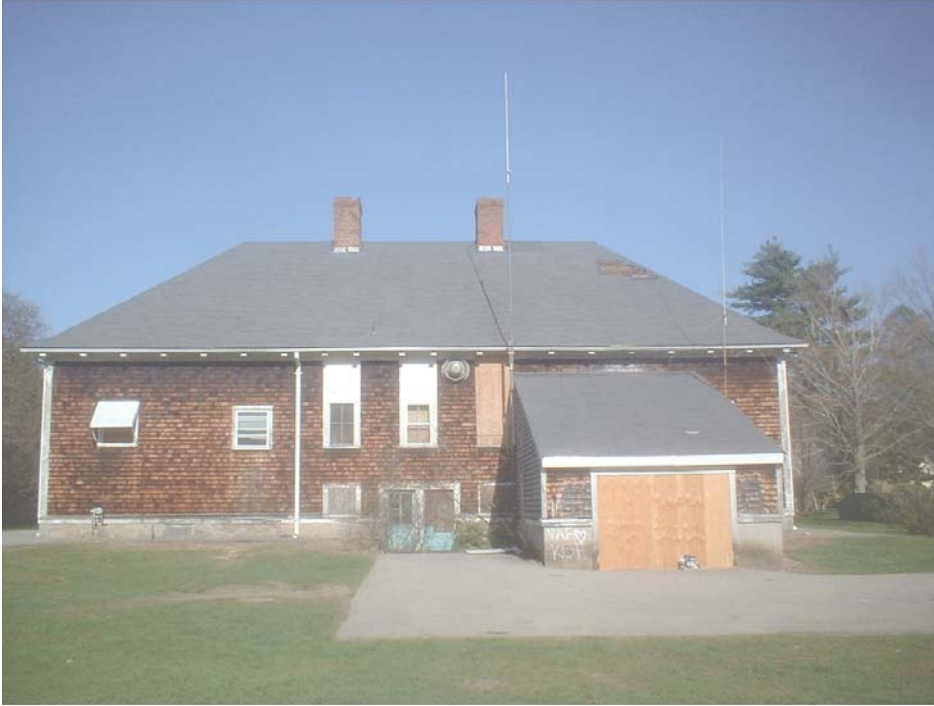
Exterior view of back facade.

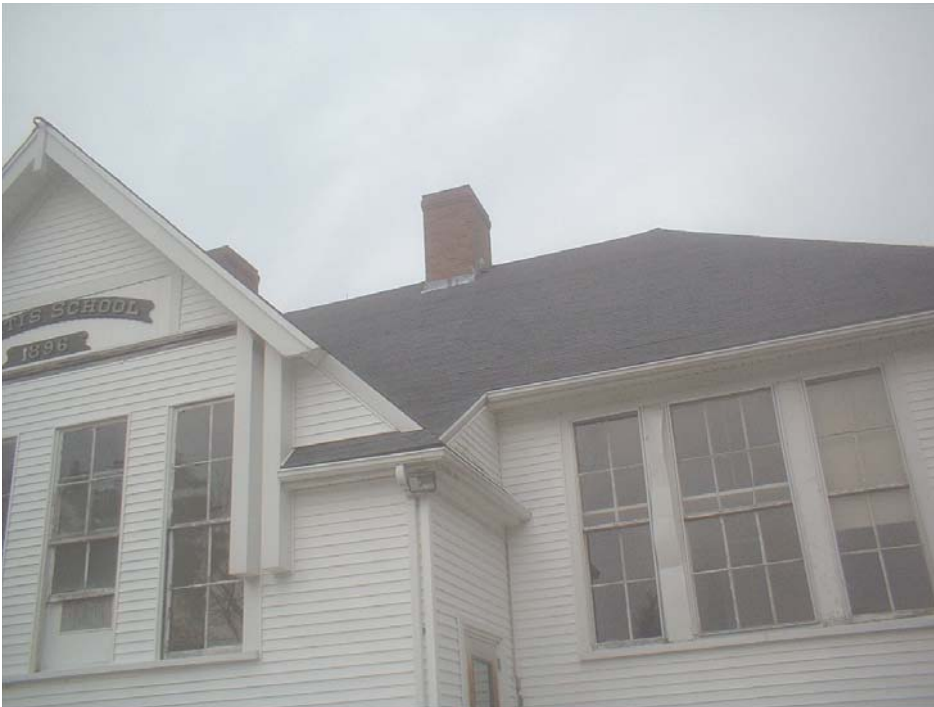
**Roof:** The roof is composition shingles, and appears to be in very poor, failed, condition. There are missing shingles in 3 locations, and evidence of previous patching. In its current condition, the roof appears to be leaking water.

Exterior detail view of roof condition.

- Repairs to roof, walls, doors and windows. Temporary repairs to stabilize the structure and halt infiltration of water and pests.
- Installation of a temporary ventilation system, to prevent further mold and help stabilize the structure.

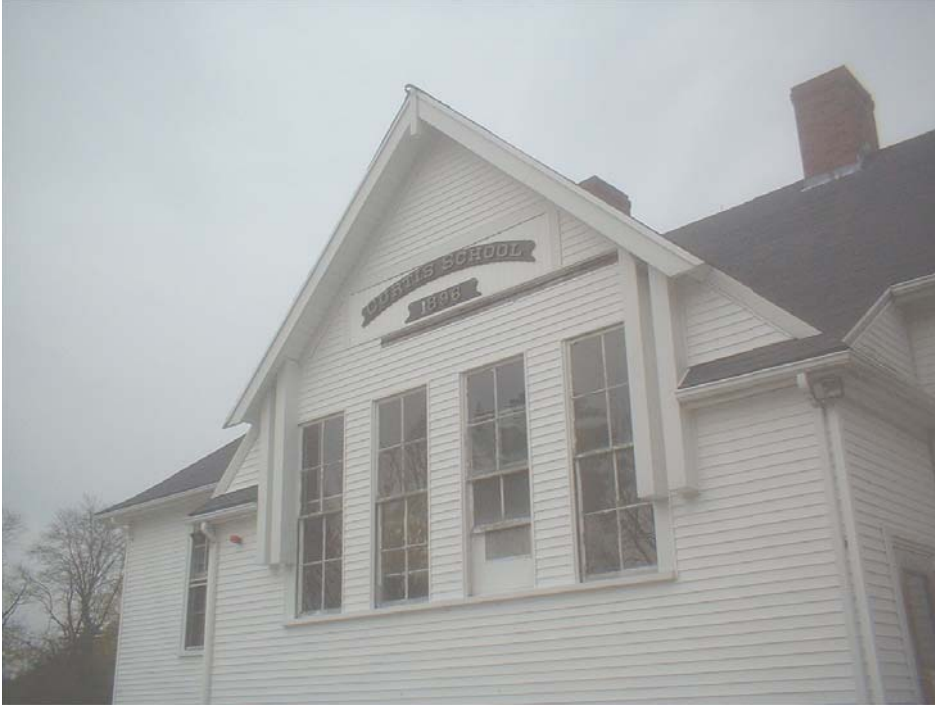
- Existing exterior cedar shingle siding on the rear of the building is in poor condition. Cracked and weathered.
- Windows are broken and some boarded, in poor condition.

Exterior, detailed view of front windows.

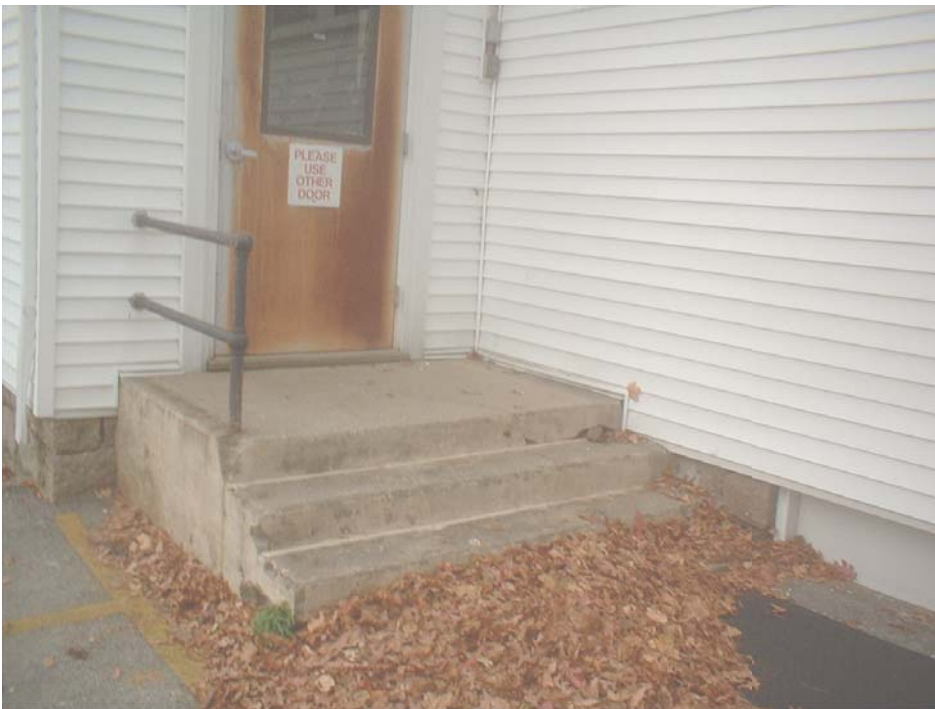
- All foundations stones on south side need repointing.
- Concrete Steps on right side entry have deteriorated.
- Mildew at roof edge.
- Rear garage addition not in keeping with rest of building.

Exterior, detailed view of stairs. Non-accessible, no guardrails/handrails.

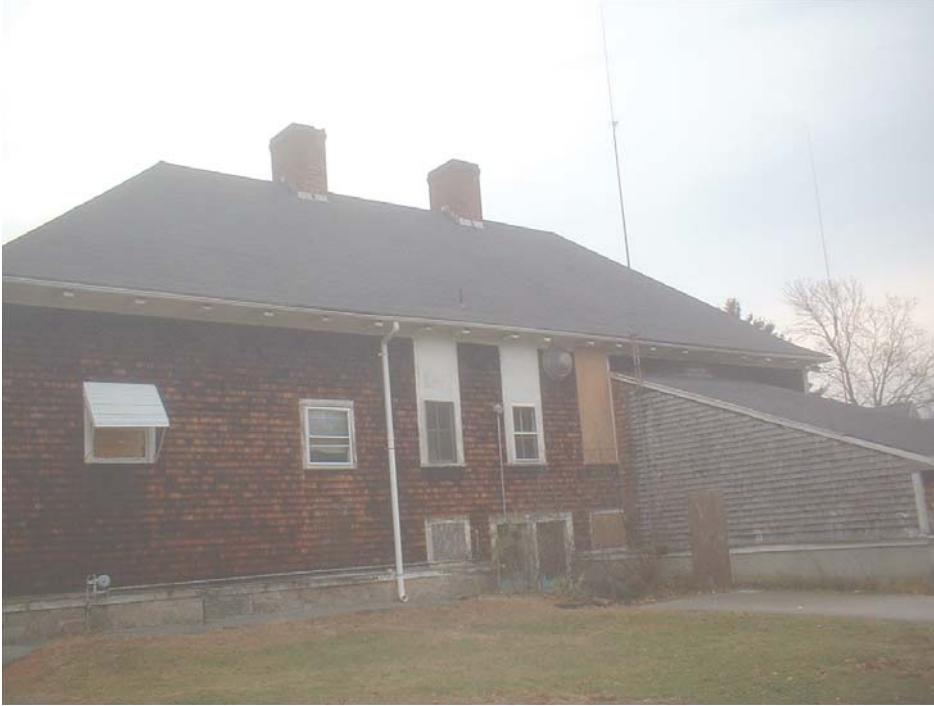
Exterior, view of back facade looking at cedar shingles.

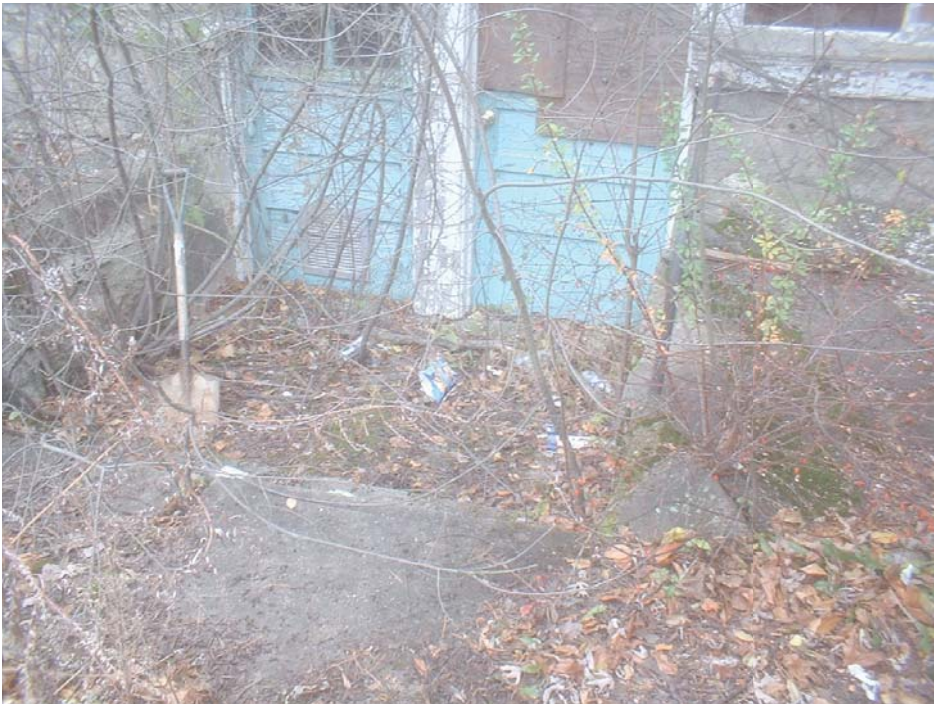
Exterior, doors to basement.

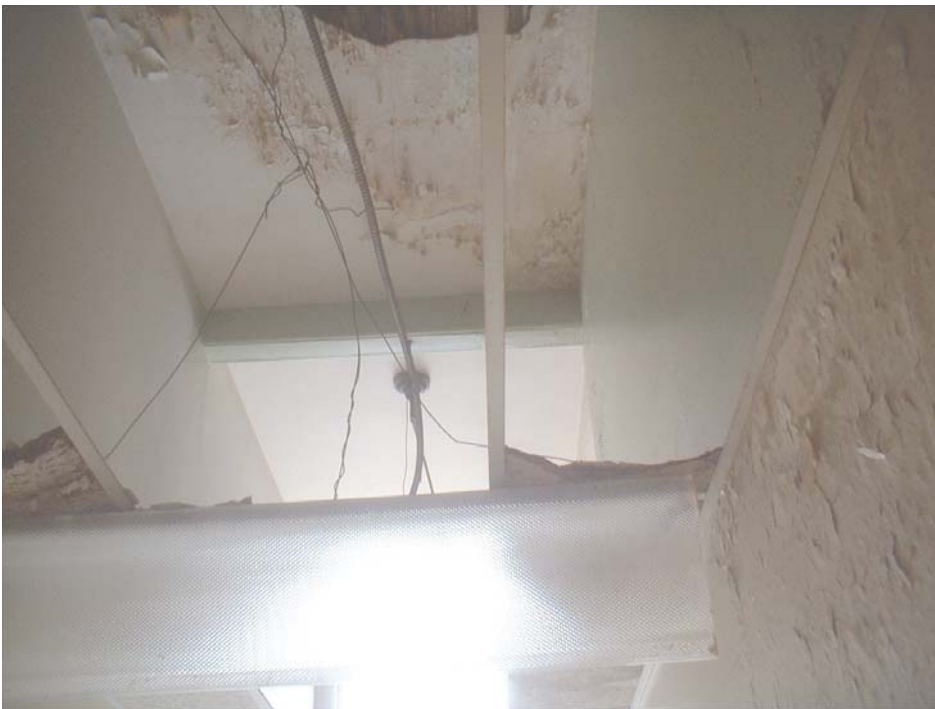
- Interior of building is completely dilapidated, with evidence of serious moisture damage and musty smells.
- Original 'tin' ceiling can be seen above drop ceiling at some areas.
- Cracked plaster.
- Peeling paint.
- Fallen plaster from ceilings at locations of leaks.
- Fallen acoustical ceiling tile; damaged and displaced tiles, damaged and displaced ceiling grid.
- Ceilings hung inside taller space split exterior windows half-way up.
- Rear garage space unfinished, with broken overhead door and boarded-up man door.
- Boarded up windows in various locations.
- Interior divided into smaller spaces using wood framing and wood paneling.
- Broken emergency light at basement.
- Fin-tube covers missing.
- Cracked and uneven concrete floors in basement.
- Low ceiling heights in basement.

Interior, view of conditions of wall and ceiling in stairs.

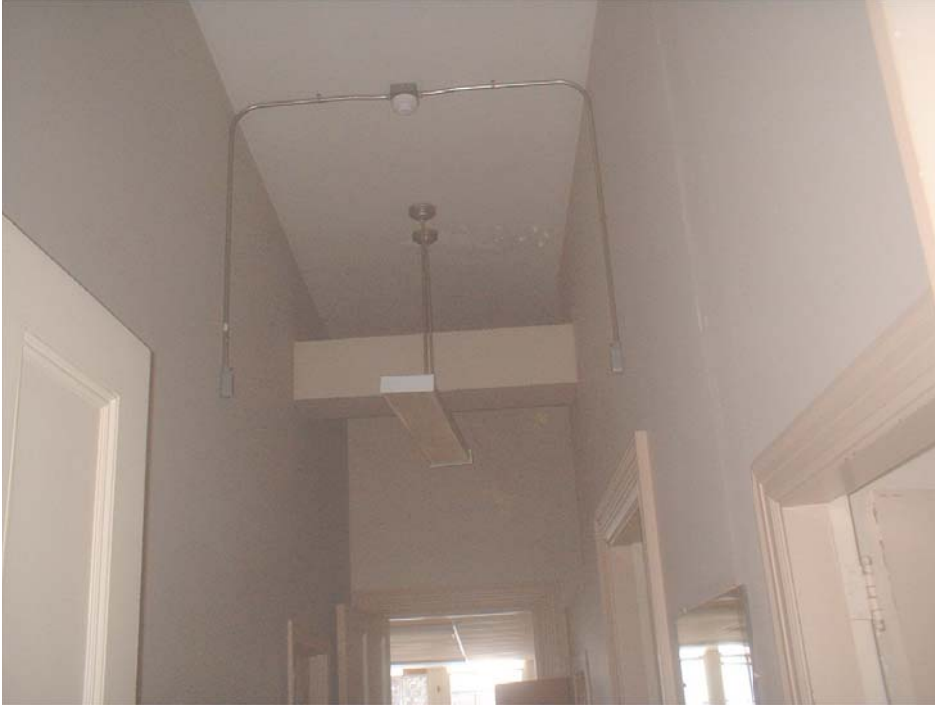
- There are a number of electrical panels located throughout the facility. These panel boards all are older having been added at the time of various building additions and/or on an as-needed basis. The condition of these panel boards is poor.

Interior, view of exposed wiring conduits.

- Warning signage and area alarm system, to prevent vandalism and reduce Town liability.
- Remove all electrical wiring and boxes from the building as part of the stabilization repairs program. Remove all plumbing fixtures and cap lines. Remove all heating equipment.
